Manhole Inspection Summary

Manhole # S23WW1012MH

Insp Date: **5/2/07 6:57 PM**

Location Address: **DEEPDENE RD**

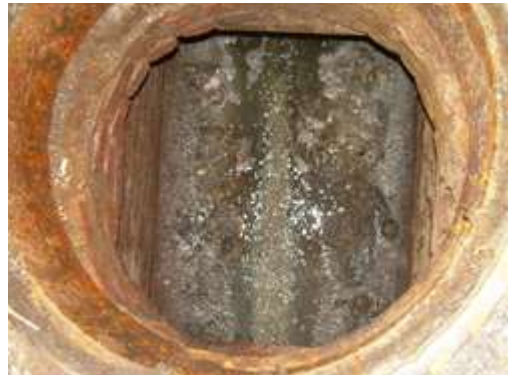
Top View

Channel debris.

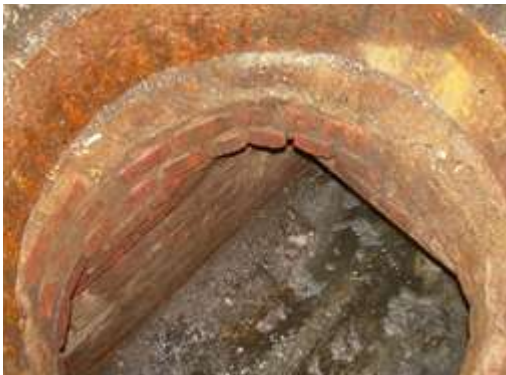
Defect

Frame Offset: **0** (in.) Condition: ☐ Sound ☐ Cracked ☒ **Leaks**

Condition: ☐ Sound ☐ Cracked ☐ Root Intrusion ☐ Loose Brick ☒ **Deteriorated**

Infiltration: ☐ None ☒ **Joint** ☐ Cracks ☒ **Mortar** ☐ Roots ☐ Wall

Infiltration: ☐ None ☐ Joint ☐ Cracks ☒ **Mortar** ☐ Roots ☒ **Wall**

Frame leaks. Frame offset. Adjustment deterioration and infiltration. Barrel infiltration.

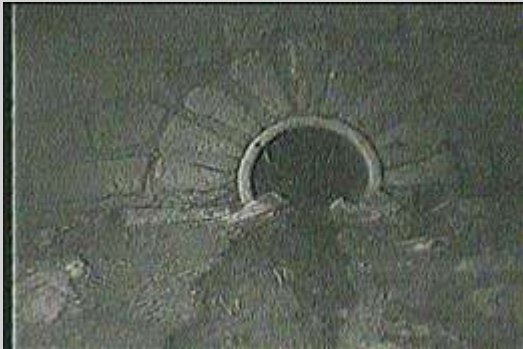
6 in. Circular Gravity Sewer Pipe Out @ 12 O'Clock

Deposits: ☐ None ☒ **Mud** ☐ Sludge ☒ **Debris** ☐ Grease

Silt Depth: **1** (in.) Deposits Extent: **Light**

Infiltration: **None** Pipe Seal Cond: **Cracked**

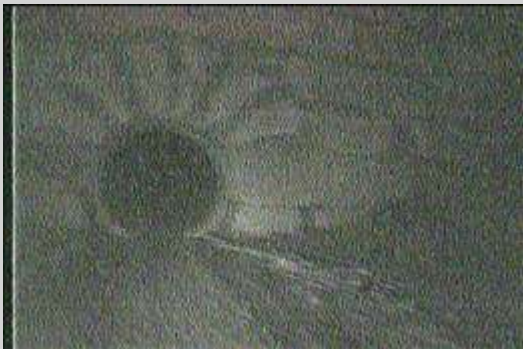
6 in. Circular Gravity Sewer Pipe In @ 6 O'Clock

Deposits: ☒ **None** ☐ Mud ☐ Sludge ☐ Debris ☐ Grease

Infiltration: **None** Pipe Seal Cond: **Sound**
